HABS/HAER INVENTORY

State Bridge Number 119

Ashland Bridge

Mt. Cuba Road over Red Clay Creek

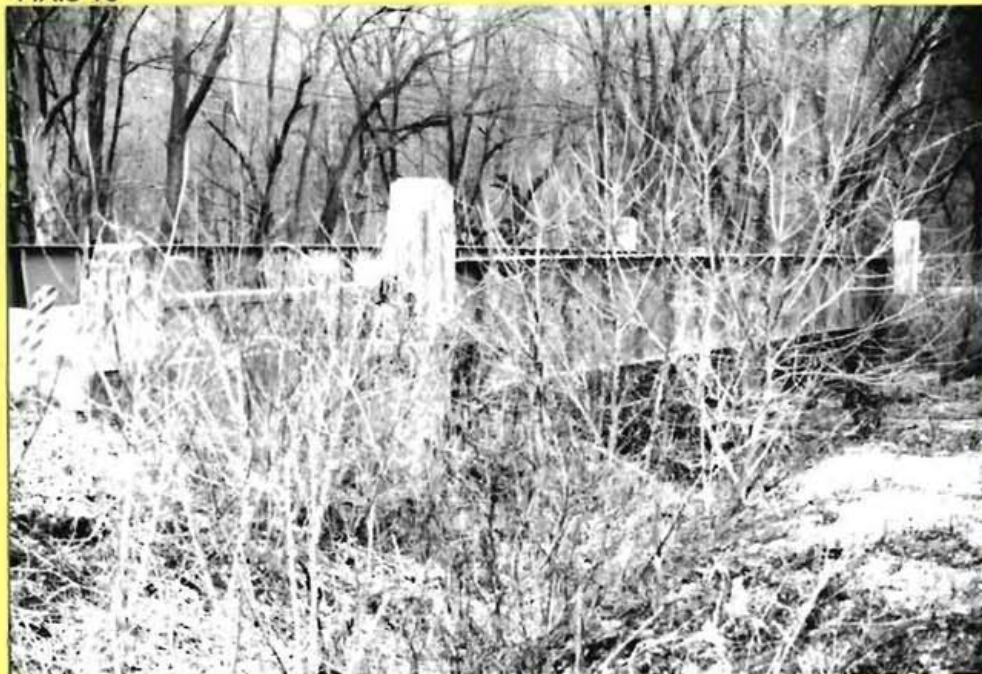
44A:3-16

Fair: Heavy deterioration of concrete curb. Many cracks with calcium deposits on underside of slab. Some rusting of structural steel. Poor approaches.
